# A Second Wind

The idea of generating electricity using the wind appeals to many, but the reality is that wind systems demand the most planning, labor, and maintenance of any home-scale renewable electricity system. Homeowners and installers don't always get it right the first time, and there are lessons to be learned when they don't.

by Ian Woofenden

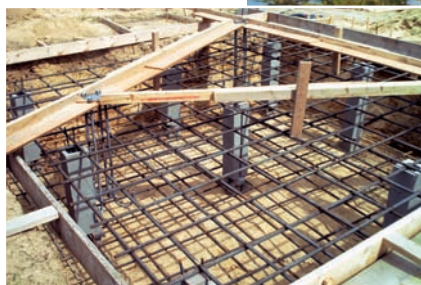
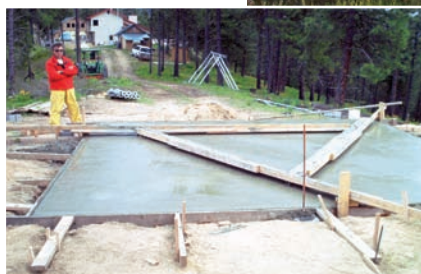
**The tower and turbine at its original site in Chelan County, Washington.**

**Inset, top: The forms, rebar, and rebar supports. Inset, bottom: The finished tower footing.**

The wind installation moved from concept to project over the next few years, with the concrete footing poured in May 2002, and the 100-foot tower and Bergey Excel turbine installed in October 2002. Randy was joined by Bill Hoffer in prepping the site, and by his western Washington crew of Kelly Keilwitz, Rose Woofenden, and yours truly for the tower assembly and crane installation.

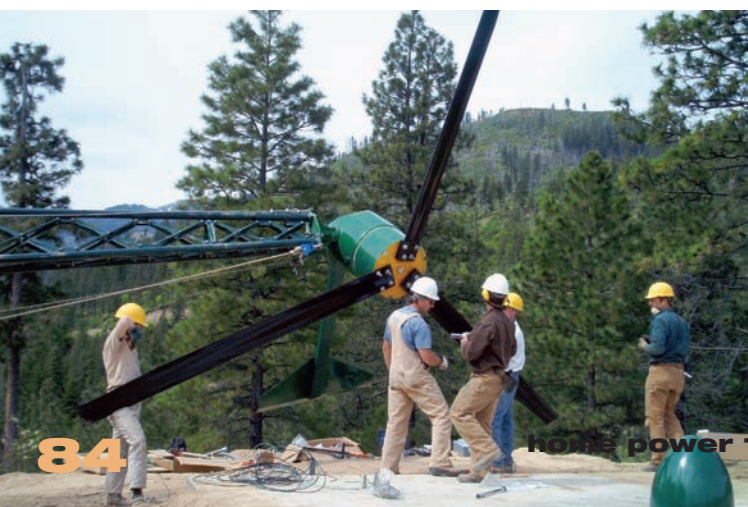
**The turbine was assembled on the tower, then lifted onto the base by a crane.**

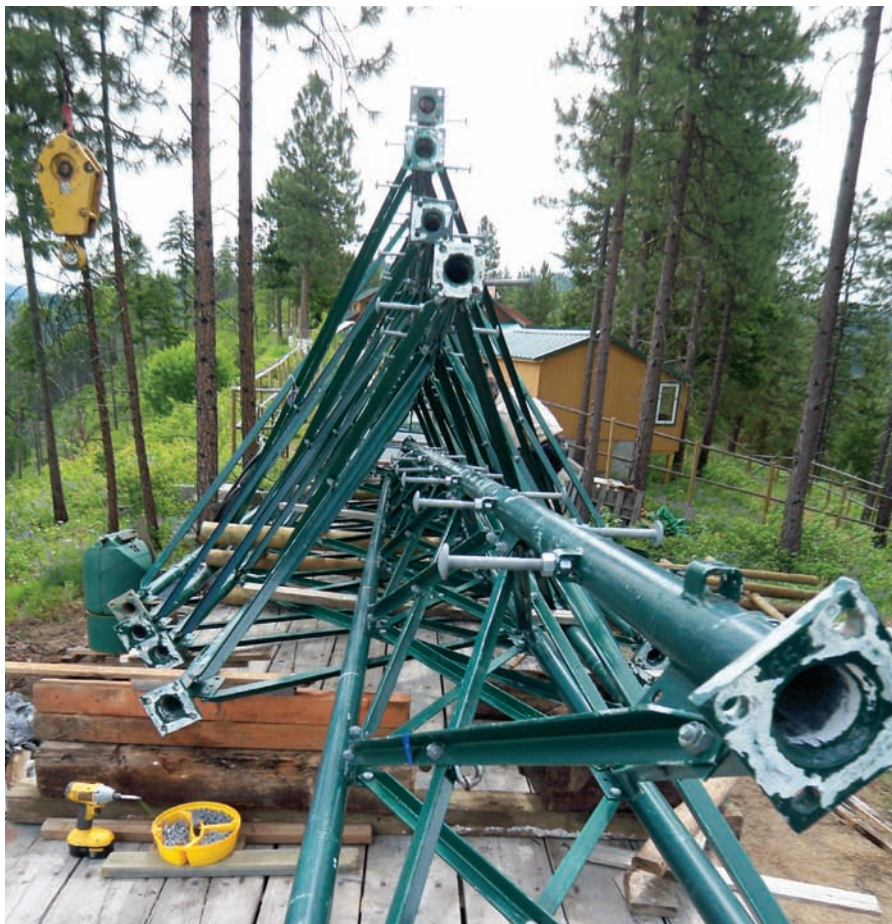
Once it was confirmed that a lack of wind was the culprit causing low energy output, the system was disassembled and loaded onto a flatbed trailer for transport to a new site.

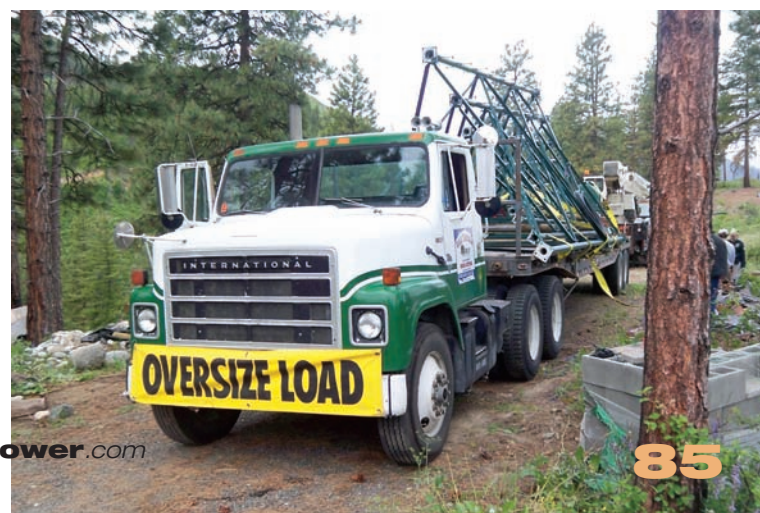
**The truck, with tower and turbine ready for transport.**

turbine 40 miles to Ellensburg. We decided to partially disassemble the tower into five 20-foot sections. This strategy worked well, and we nested the sections on the semi, with the turbine strapped down on the back end. All then headed south, leaving a bare concrete slab at the Grim property.

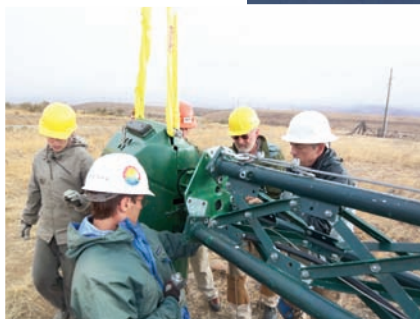
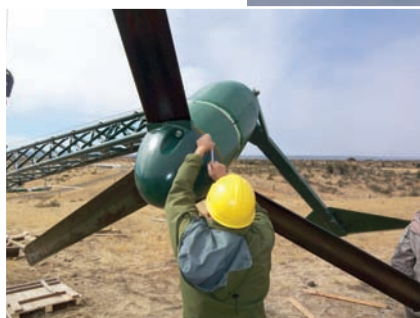
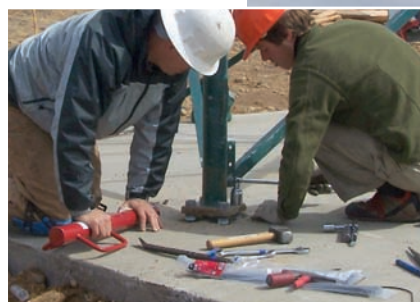
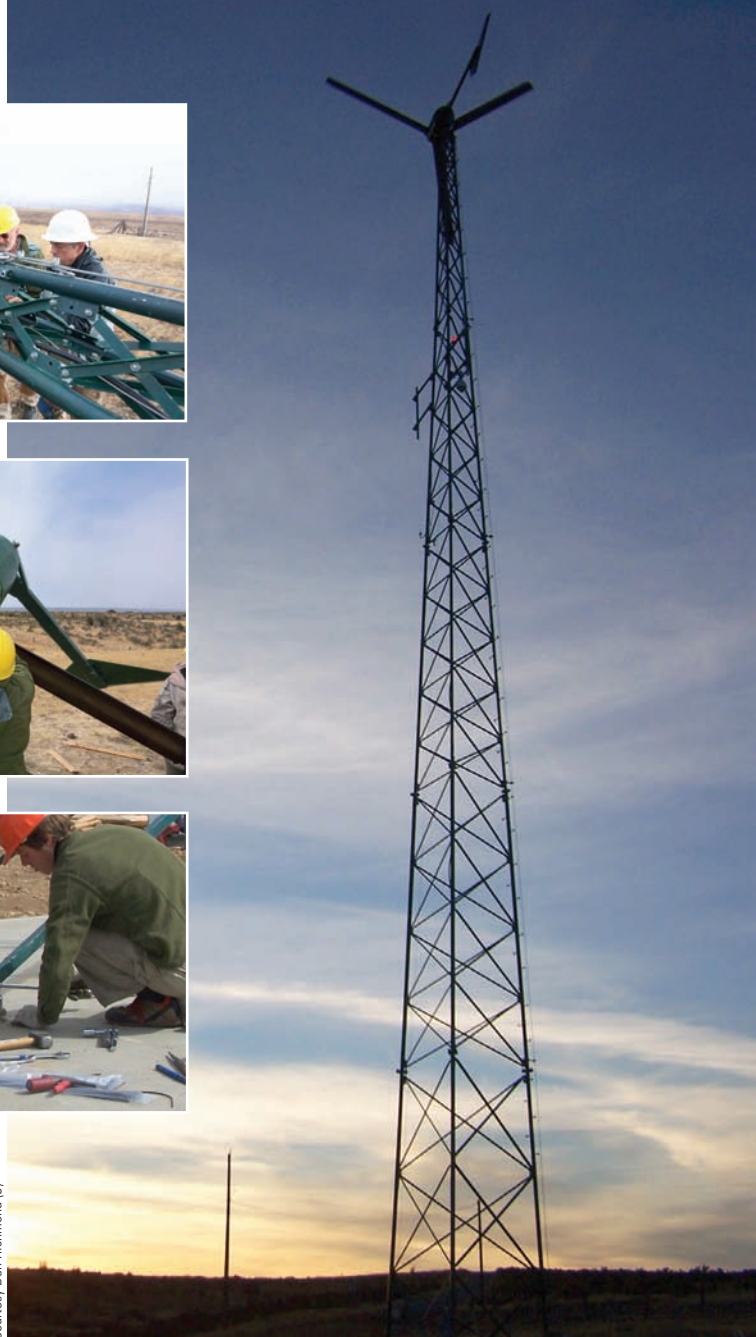
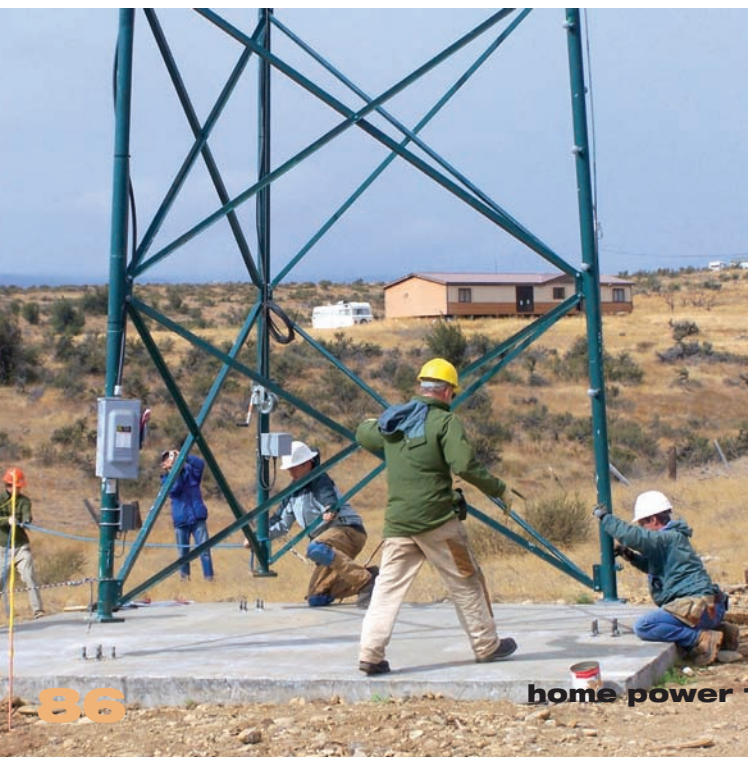
**The turbine and tower are reassembled and hoisted at the new site—one with a considerably better wind resource.**

The crane lifted the tower so we could prop it up for room to install the turbine. We then lifted the turbine head and bolted it to the tower, followed by the tail and new, next-generation blades. The blade upgrade led to some head-scratching over the installation hardware and a field modification to make the nose cone fit properly. Meanwhile, with transmission wires secured, furling cable attached, and damper completed, we were ready to lift.

Once the tower and turbine were up, we ran ground wires to the ground rods, and performed electrical and furling tests on the turbine. We left the turbine running unloaded, an acceptable condition for this particular model.

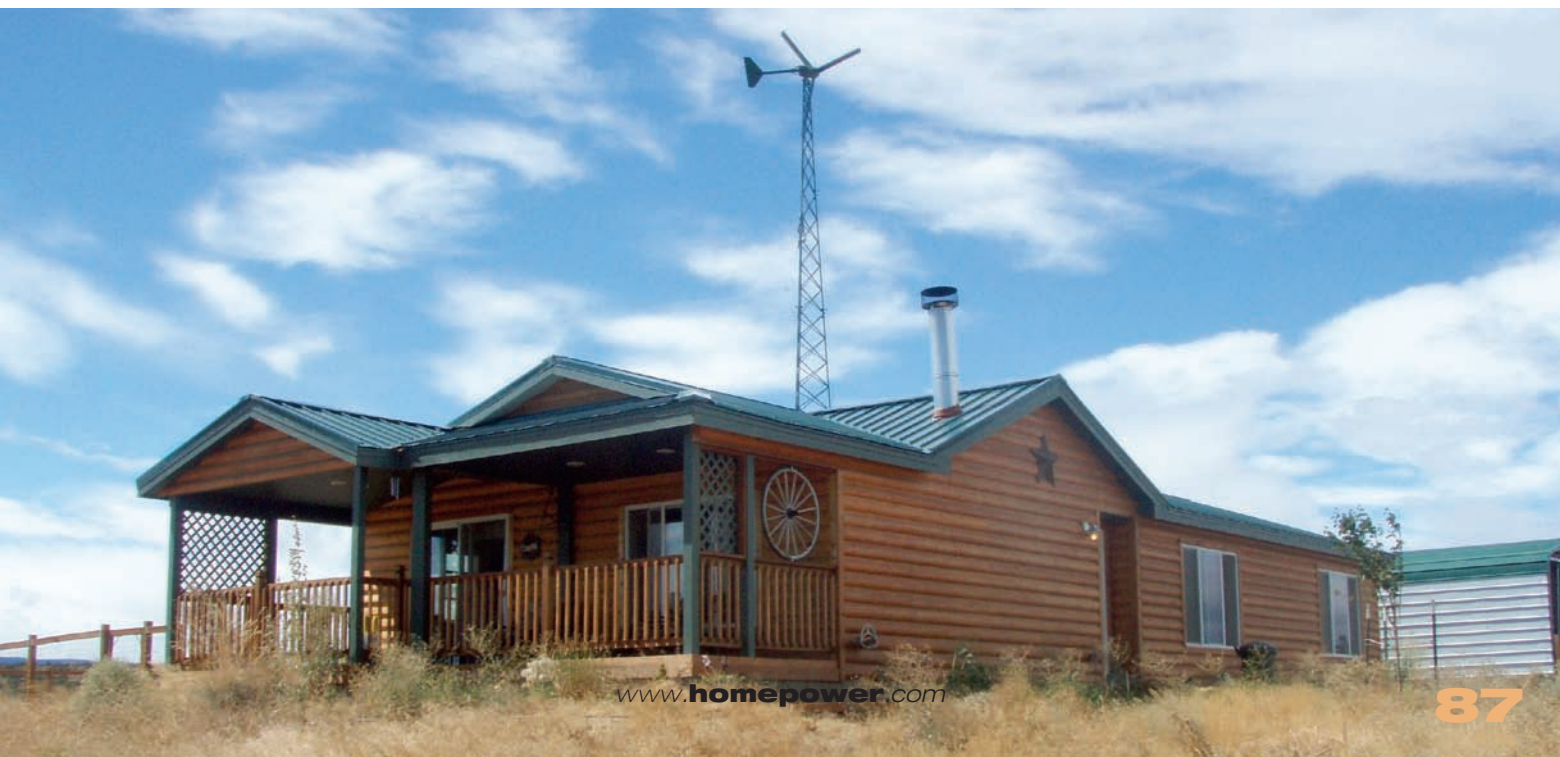
**The turbine and tower, at their new home on the range.**

system has produced 2,047 kWh, or an average of 23.8 kWh per day, a far cry from the low performance at the Grim site. Average wind speed at 33 feet was 8 mph in the fall of 2008, and, Randy estimates, probably 1 to 2 mph higher at the turbine hub.
